Builder's Log -- Helicycle N750G

August 3 – I began inventorying the parts and inspecting the work that had already been done by the three previous owner/builders. Here is a partial list of work that was completed when I purchased the kit:

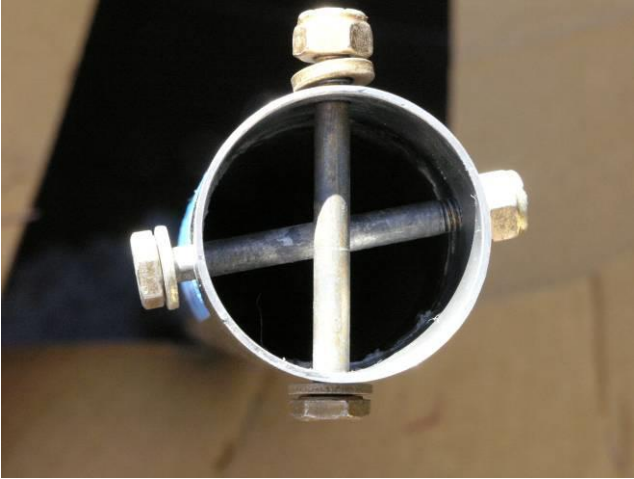
I next inspected the tail rotor drive shaft sections and their bearing assemblies. Here is an example of very poor workmanship. These two bolts should be at right angles from each other. The hardware also appears to be well used and slightly corroded. I will replace it all including the tubes. (NOTE: New tubes arrived on August 30)

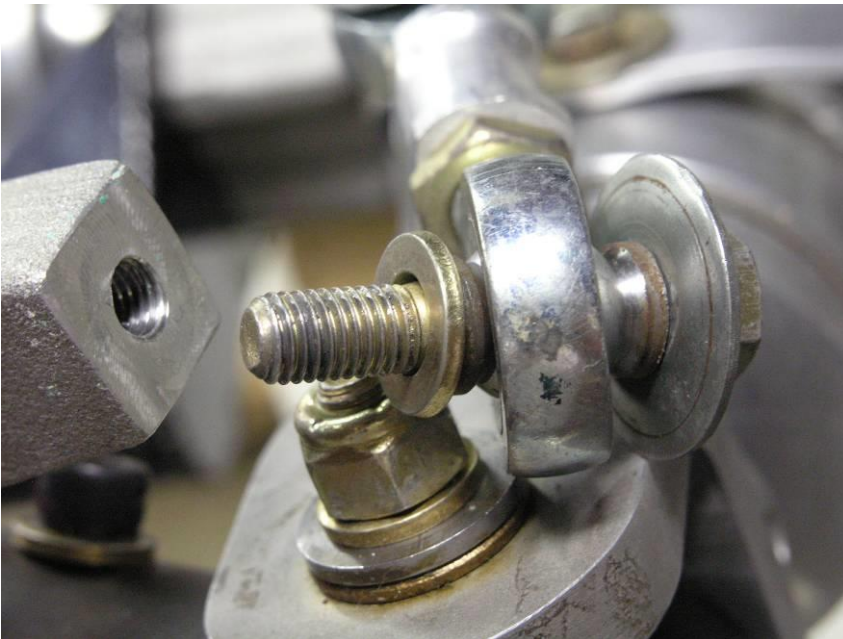
August 13 – I have been suspicious of the tail rotor drive shaft since the hardware showed signs of corrosion and the components were filthy and looked very used. This evening I was taking a close look at the tail rotor which was supposedly preassembled at the factory. I noticed that one of the bolt/washer stacks that attach the bearing end rod to the pitch horn was loose. When I attempted to snug it up the bolt bottomed out.

In this picture you can see that the bolt has run out of threads and there is also evidence of corrosion. All of the components appear to be scraped and dinged.

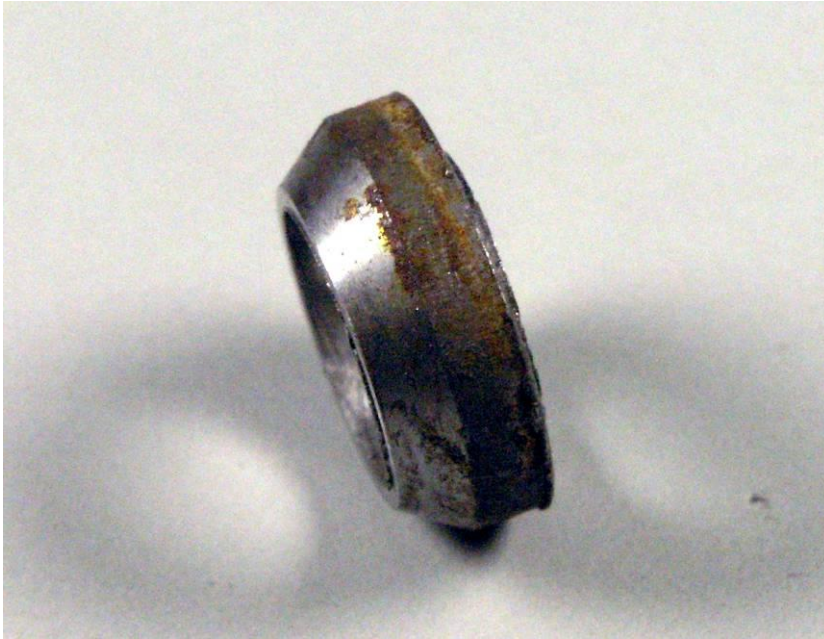
Here is a detail shot of one of the chamfered spacers from that stack. I will scrap these out.

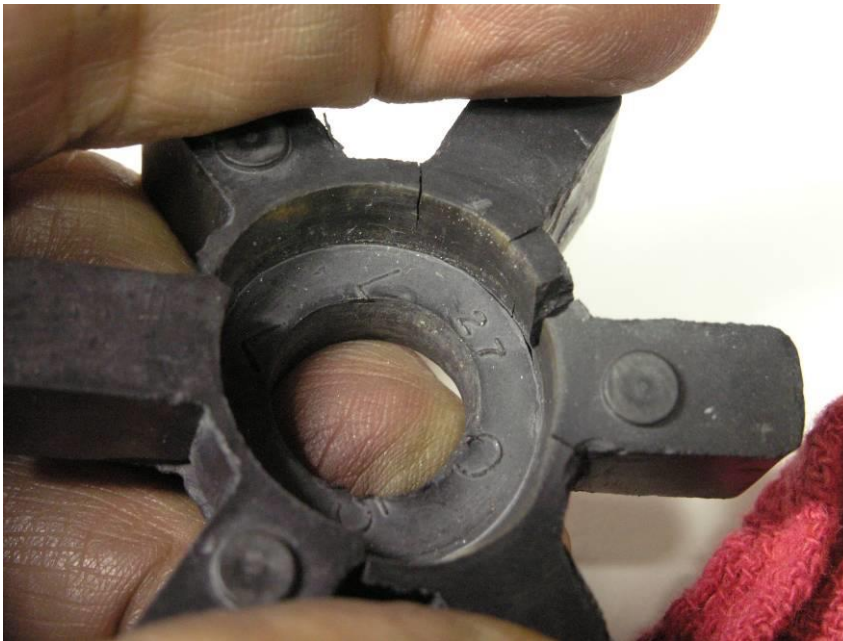
Here's more evidence that the tail rotor driveshaft and tail rotor components are in extremely bad shape. Both coupling spiders are completely shot and full of cracks. As I mentioned, all of the hardware associated with the drive shaft appears to have been pulled from a junk yard after years sitting in the weather. All of this will be replaced before final assembly. (NOTE: New rubber spiders arrived August 30.)

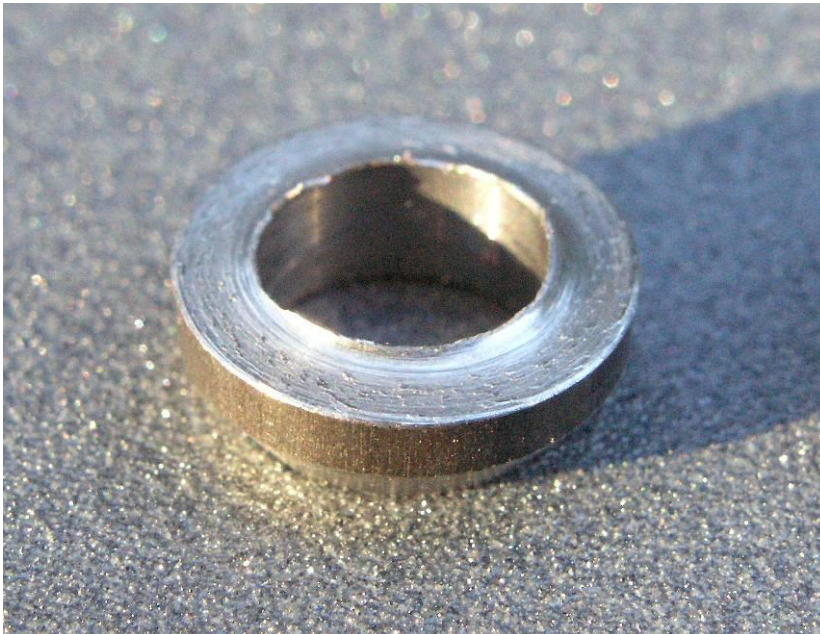
Here is a picture of one of the replacement chamfered spacer, P/N 21-115. They are all very rough on the bottom side and needs to be deburred.

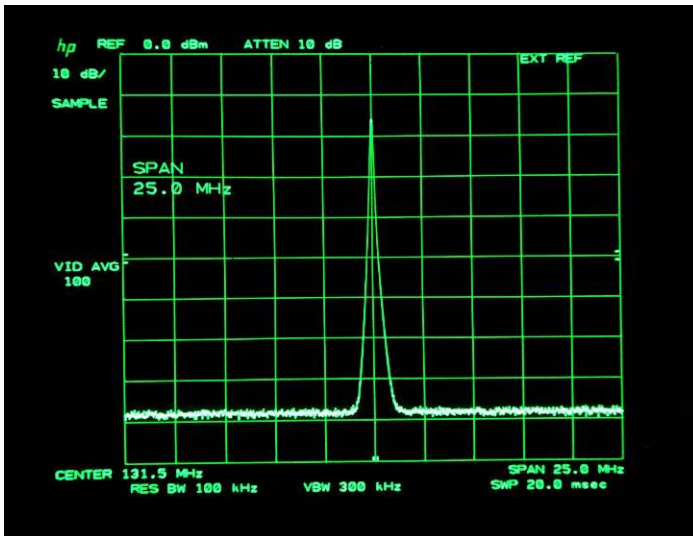
This is the spectrum of the IC-A210 transmitting a carrier with no modulation. The spec for spurious emissions is -60 dBc (decibels below the carrier.) This transmitter exceeds that spec by more than 10 dB over a 25 MHz span.

There's a small spur at 26 kHz, probably switching power supply ripple. It's down 73.4 dBc.

The IC-A210 is off 36 Hz at 125.000 MHz in this bench test. The spec is ± 5 ppm, or 625 Hz.

Bottom line – the radio is performing as expected and exceeding the transmitter specifications for output power and spurious emissions.

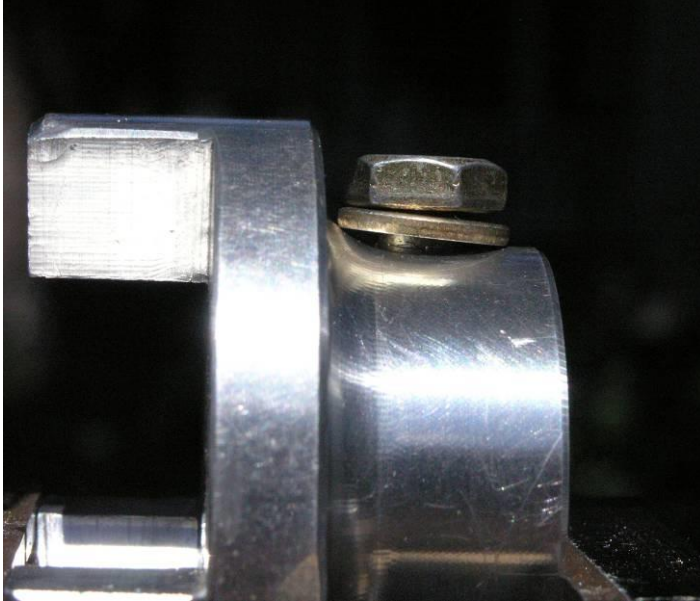
This morning I spent two hours carefully match-drilling this tail rotor coupling's 1/4" bolt holes. They had to match the existing gearbox shaft and not have any slop. Slop in the old coupling was caused by ovaling out the hole by a previous builder. The final sizing was done using a reamer and it came out perfectly.

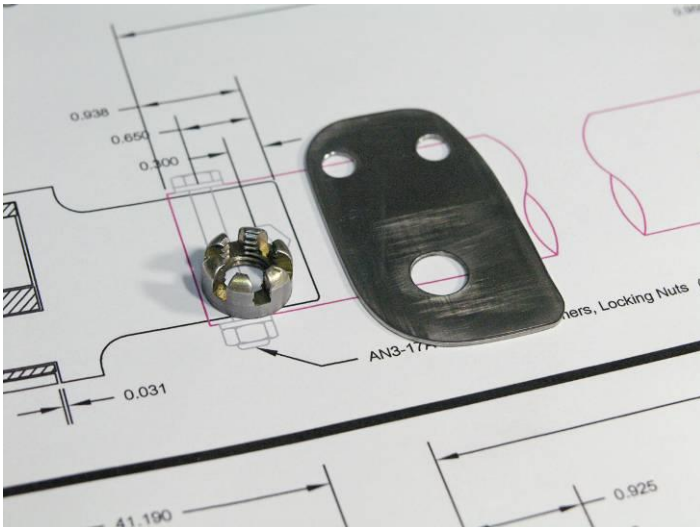
After finishing the work shown above and assembling the mixing assembly I found that the piece shown on the previous page seemed to slightly bind at one end of its travel, as it was rotated. I discovered that the pieces that fit inside of the assembly (the piece in the previous page plus one other) were 0.31" thinner than the inside dimension of the steel welded piece that forms the heart of the assembly.

To get around this 0.031" discrepancy I fabricated a 0.031" thick stainless steel shim. It doesn't look like much but it required a trip across town to the metal supplier and considerable effort to complete.

Here's is the finished shim and the modified castle nut. The shim completely fixed the binding problem and I am now ready for the last step.

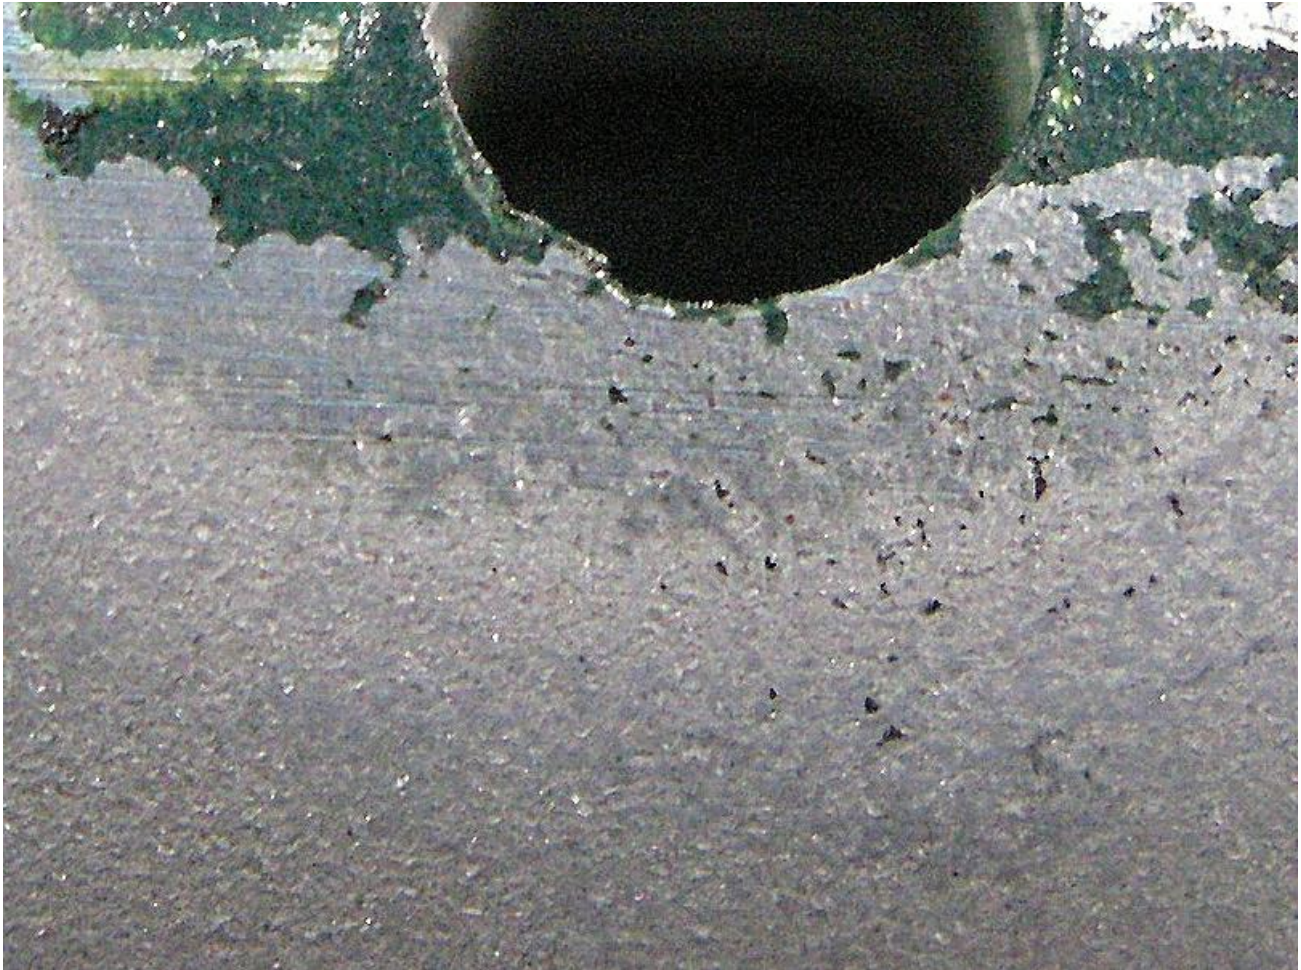
These tubes are stressed and are critical to flight. All of these pits must be blended out to prevent stress risers that could develop into cracks. I can't afford to have one fail. If I can't blend these pits out then I'll have to scrap all of the push-pull tubes and order new parts.

I'll have to think about how I want to proceed with these tubes. There is no room for error. I'll come back to it later.

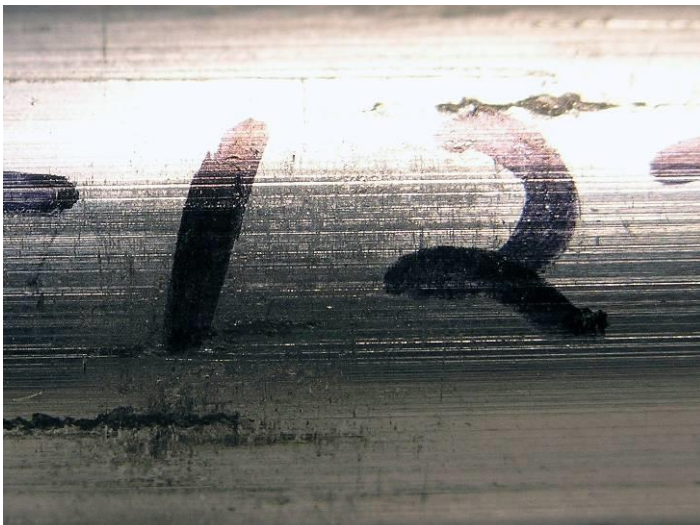
To the left is a close up of one of the pitch links before beginning. Notice all the mill marks, dings, and scratches. They all need to be removed. Aside from improving the appearance of the parts, polishing will retard oxidation by eliminating all of the microscopic pits and voids where corrosion can begin. It will also be easier to inspect polished parts for damage.

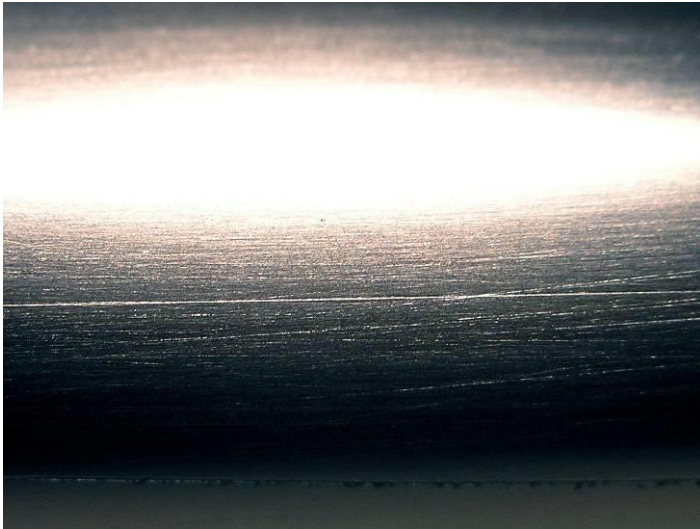
Here's the same piece after sanding with 1500 grit. At this point I noticed that deep horizontal scratch seen here. I could actually feel it with my fingernail.

One reason for polishing is to remove these potential sources of cracking that could lead to structural failure.
