JUAN RIVERA HELICYCLE BUILDER LOG #2
FUEL PUMP AND FUEL CONTROL CLEANUP

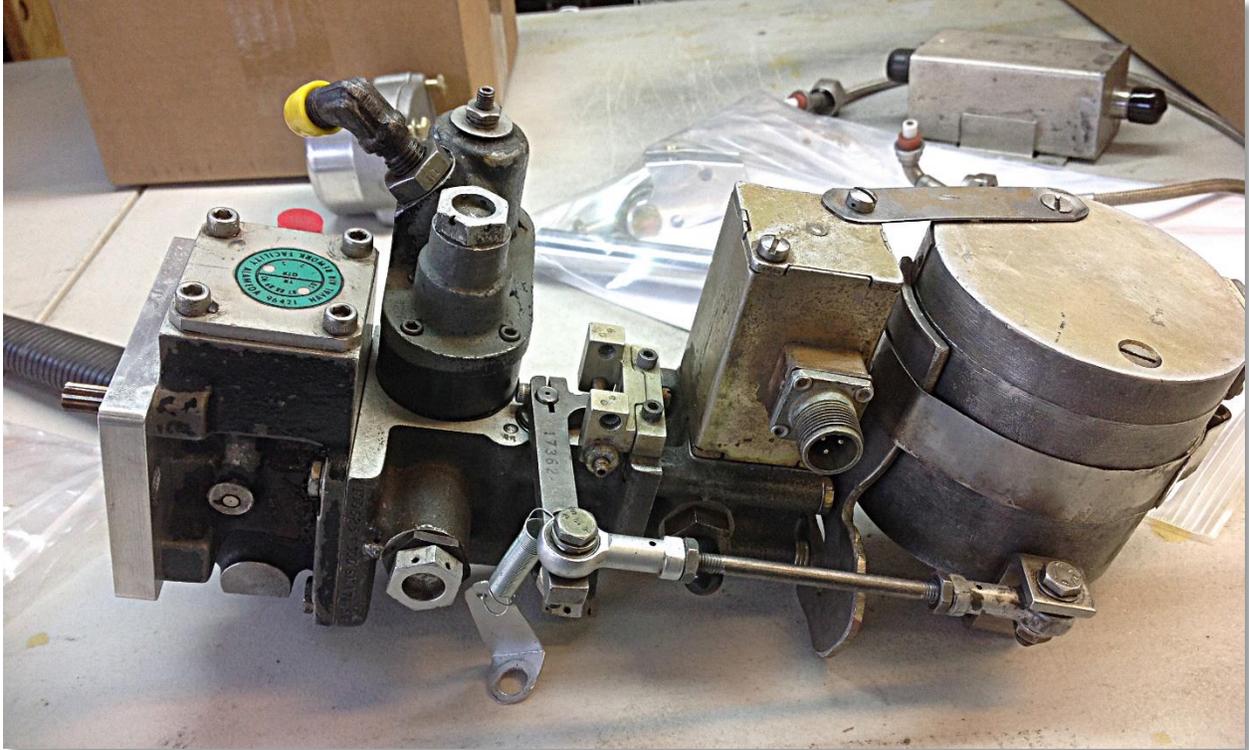
My engine looks pretty clean but this fuel pump and fuel control assembly looked really nasty. I decided to partially tear them down and clean them up. This is what the assembly looked like to begin with.

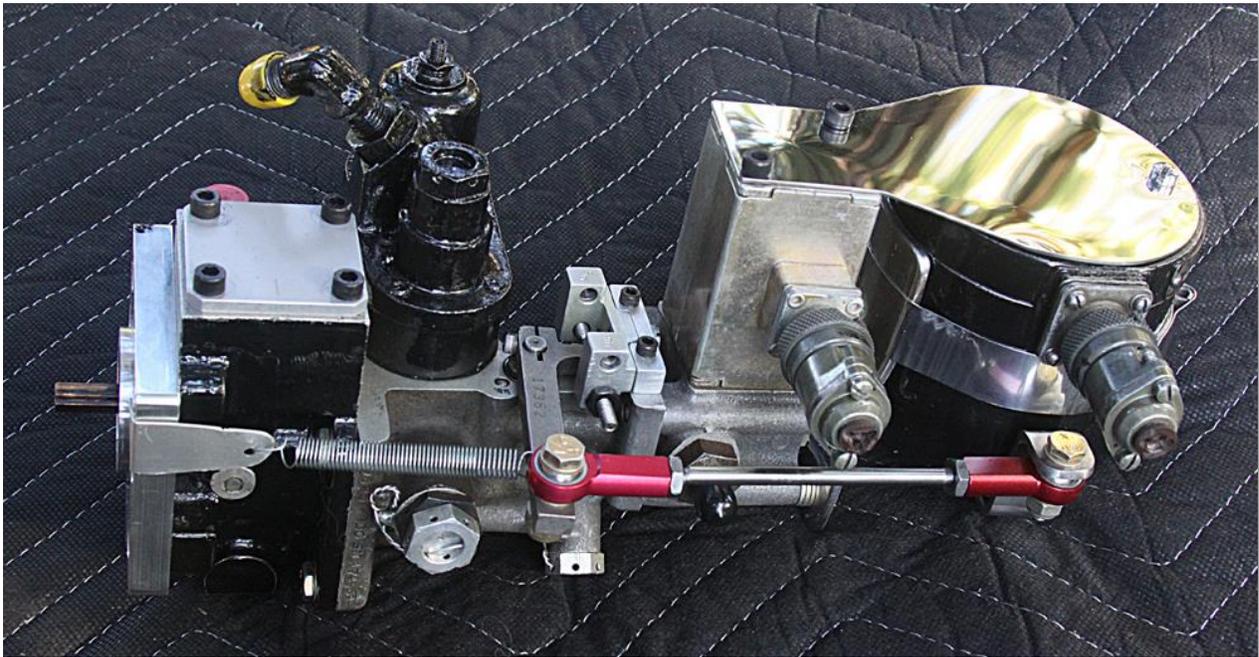
And here is what it looks like now.

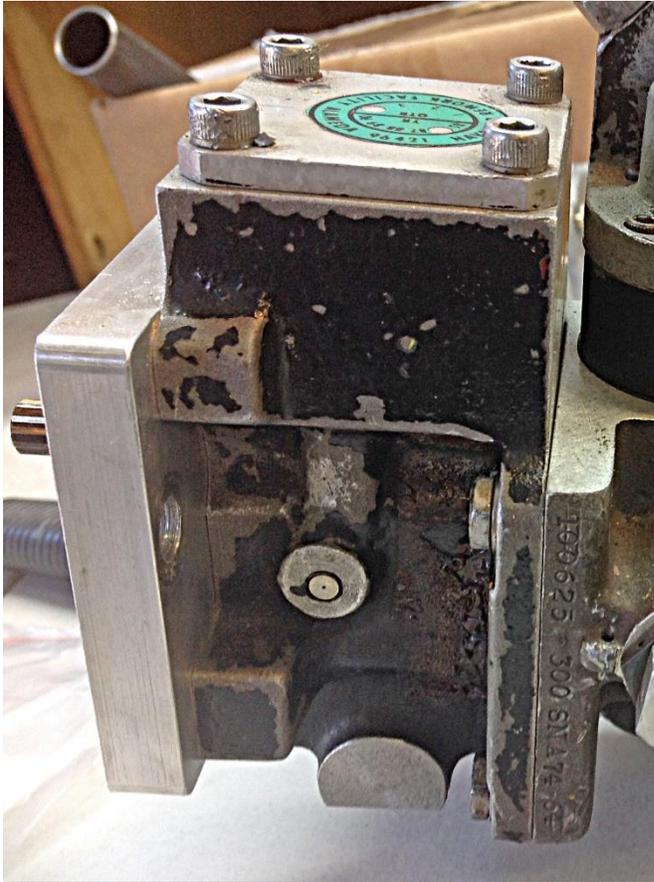
I started with the fuel pump assembly which I removed and tore down. I pulled the mounting pad and filter cover off and polished those parts. I also replaced the hardware.

The paint was in poor shape so I decided to blast it off and repaint with POR-15. After removing the filter cover and mounting pad I carefully sealed all the openings with aluminum tape.

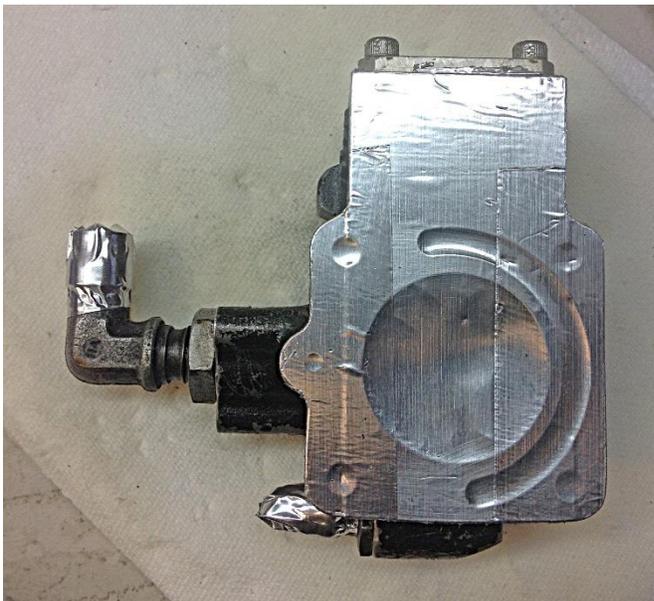
Here's the pump ready to blast. I used fine ground glass and I was extremely careful to seal every opening. After blasting I inspected the pump with a magnifier and cleaned out any specs I found with a Q-tip and alcohol.

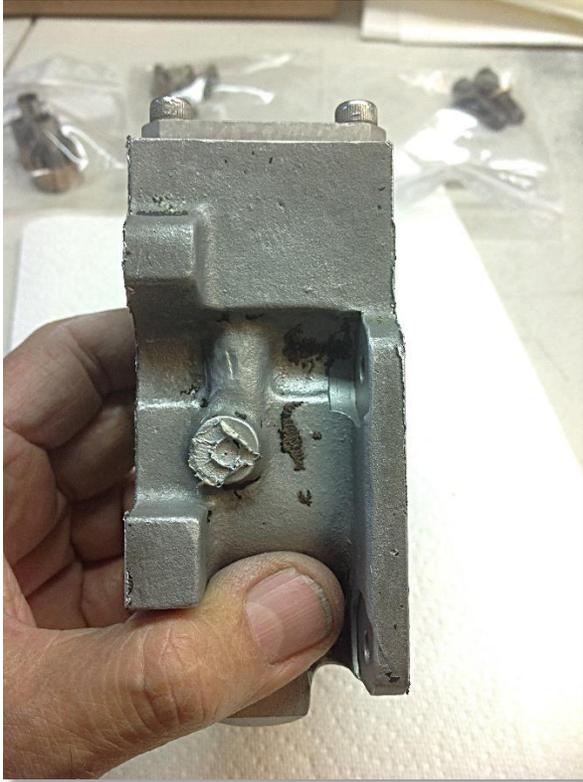
Here's the pump housing after blasting it with fine ground glass. The few remaining flecks of paint are solidly bonded to the aluminum.

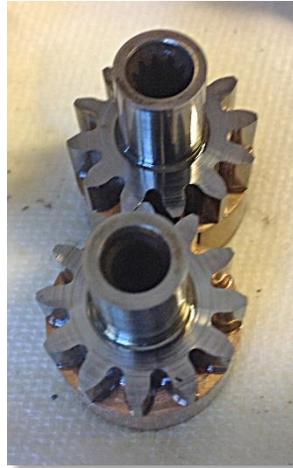
I also pulled the internal components out for a visual inspection. If you do this be very careful as there are many very small parts inside including little springs and O-rings. Also the gears and bearings are not interchangeable and must not be switched.

Here's a shot of the drive gear and the driven gear. They are sitting on their front bearings (brass.) After reassembly and painting I set the pump aside.

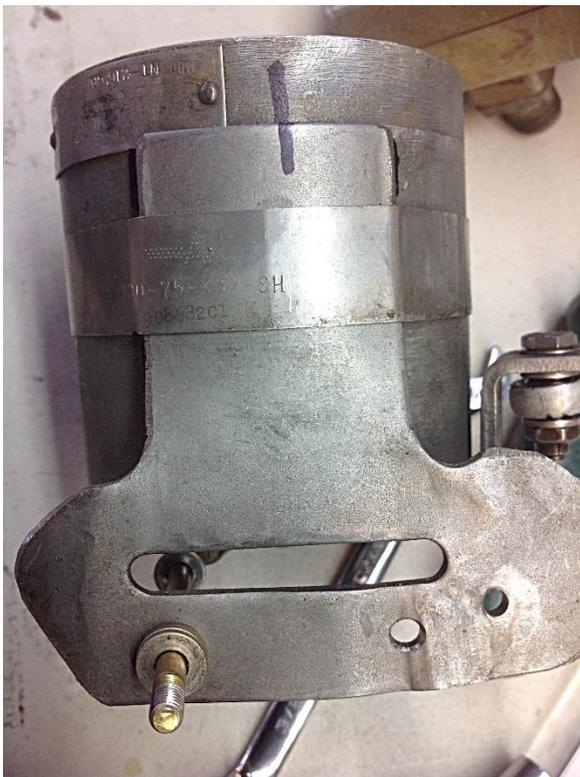
The torque motor had seen some hard times and this mounting plate looked like it had been fabricated out of some scrap. The slot and the ears served no purpose at all, so I cut the ears off and went after the plate with my deburring wheel and polisher. It's stainless and polished up nicely. I also polished the clamp which was also stainless.

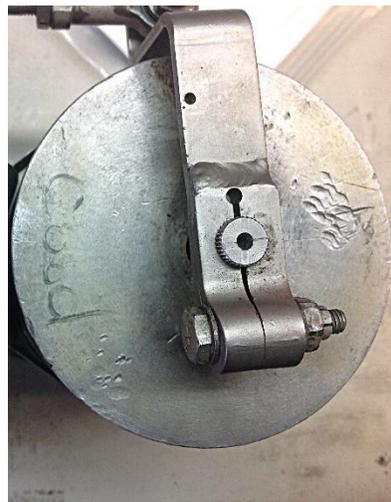
The bottom of the torque motor has a small crack and what looks like many hammer marks over the crack. There isn't much I can do about that.

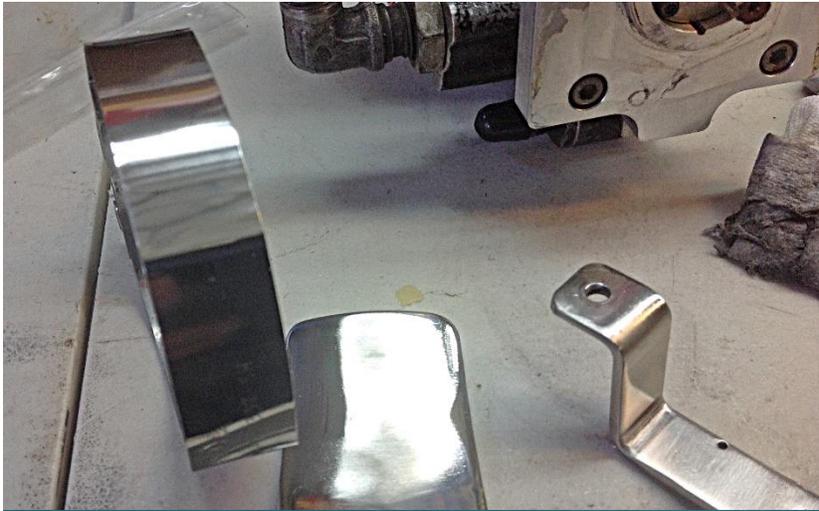
Here's that torque motor clamp, mounting plate, and the actuator arm after polishing.

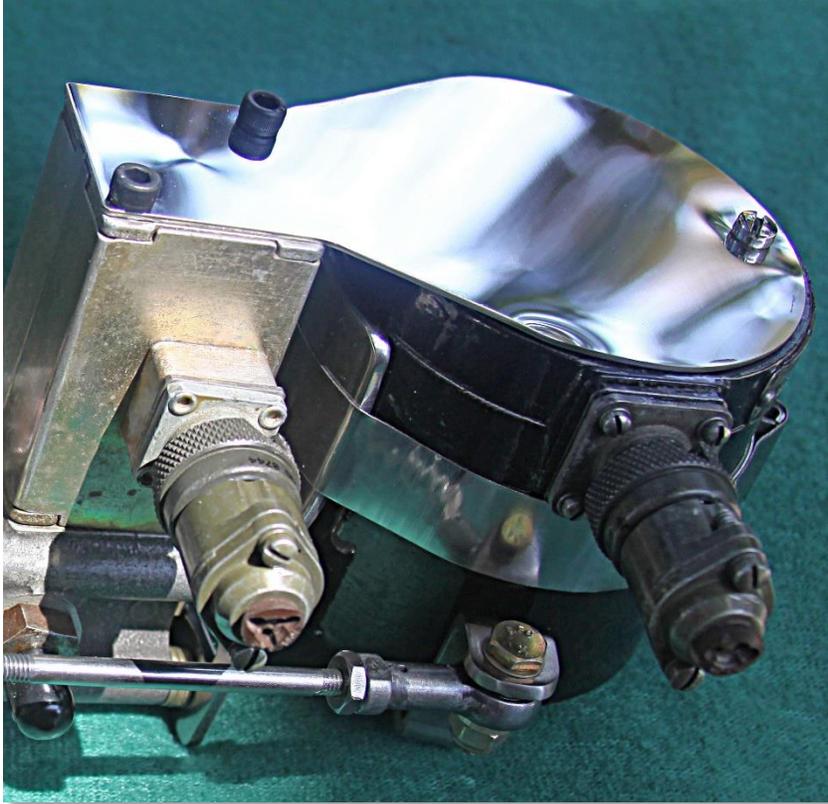
Here's the painted torque motor and new stainless top plate I made for it. I took the opportunity to rotate the motor ninety degrees so that the connector comes out parallel with the start fuel solenoid's connector. That will make for a cleaner-looking cable harness. The torque motor has a slightly wider range of motion than is required to move the throttle linkage from stop to stop, so all that is required is to insure that the actuator arm is installed in the middle of that range when the linkage is also in the middle of its range.

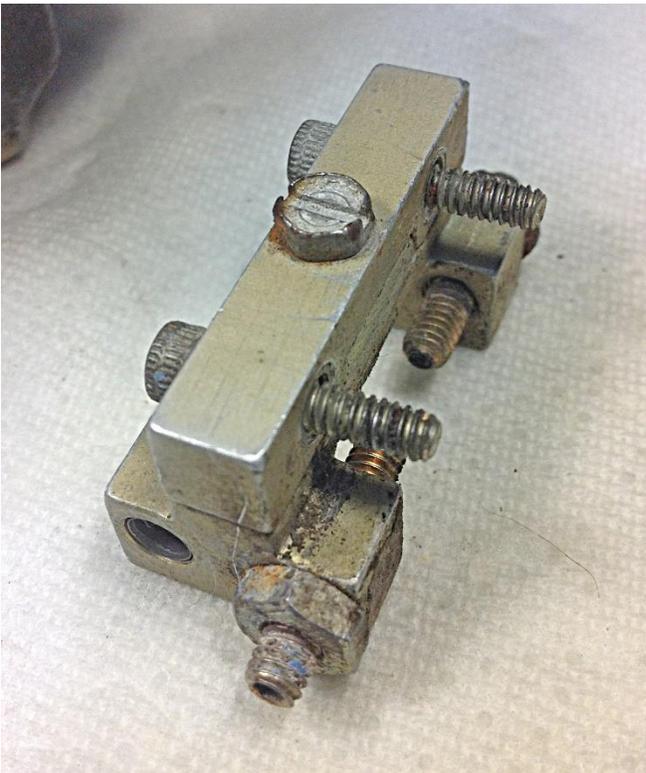
The throttle stop assembly was typical of the controller as a whole. There was a lot of dirt and corrosion everywhere. I replaced all the hardware with black stainless steel and the throttle stop set screws now have Nylon tips. Not necessary of course, but why not?

I may replace the small Heim rod ends on the throttle linkage later since they feel sticky to me.

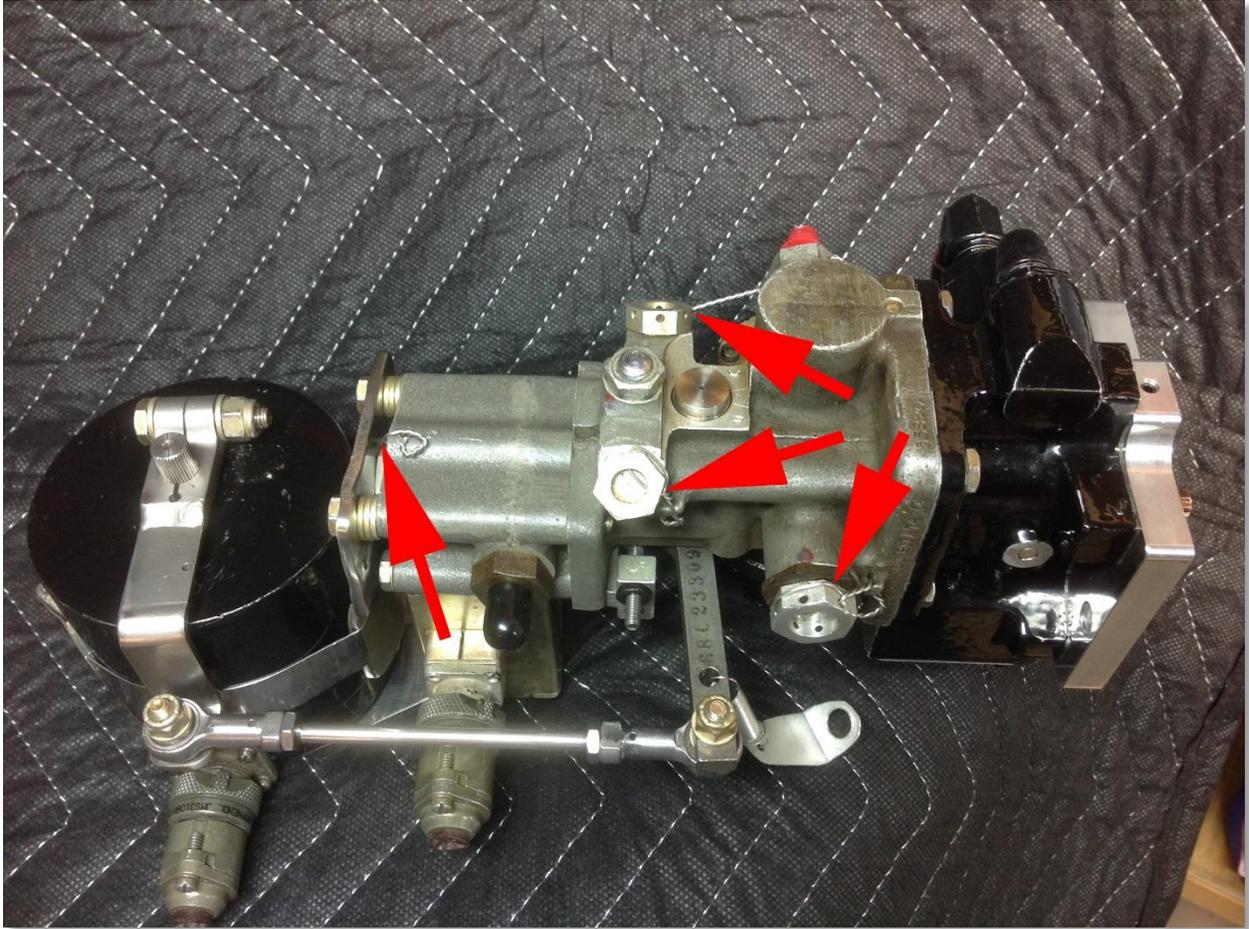
Here's a view of the bottom of the assembly after the work was completed. I safety wired the four caps and in the process I noticed that the throttle linkage rod was too short and the fuel control lever and the torque lever were not lined up very well. I wanted the two levers to be parallel as you see here so I fabricated another rod out of stainless and polished it. Now the torque motor is operating in the middle of its range and the two levers track nicely.

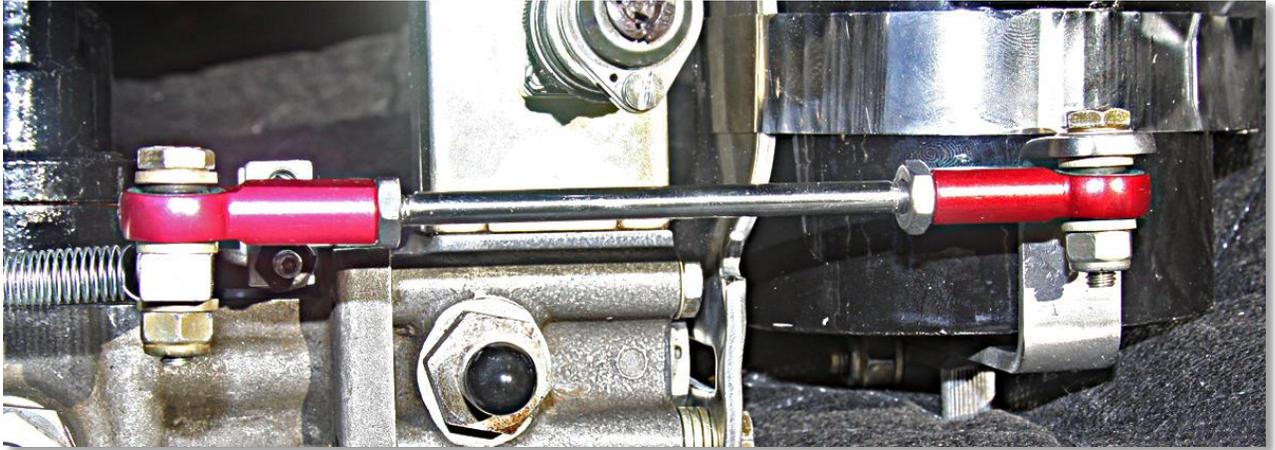
I replaced the old stiff Heim joints with new anodized aluminum ones and also adjusted the torque motor lever's height on the splined shaft so that the rod ran parallel to the direction of motion.
