Builder's Log -- Helicycle N750G

August 3 – I began inventorying the parts and inspecting the work that had already been done by the three previous owner/builders. Here is a partial list of work that was completed when I purchased the kit:

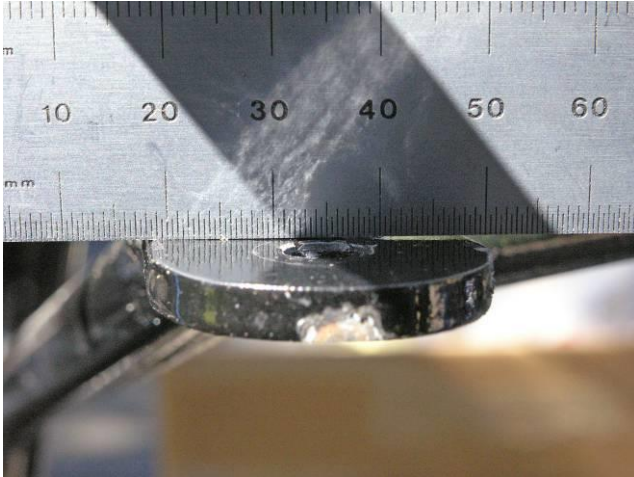
By placing a straight edge across from the left hand mount to the right hand mount you can see that the left mount needs to be bent slightly counterclockwise. The right hand mount also required slight readjustment.

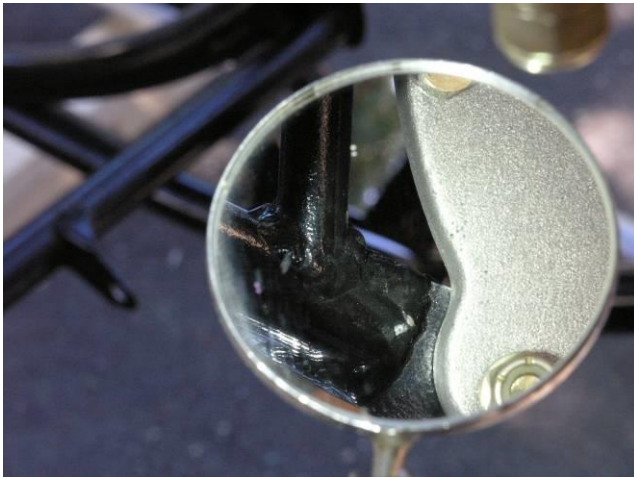
This inspection mirror view of the bottom side of the left transmission mount shows that the weld bead is well clear of the transmission case.

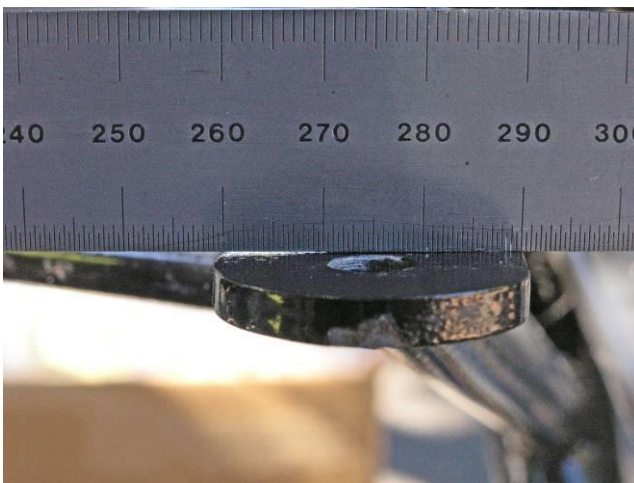
Here you can clearly see that the right hand transmission mount needed to be straightened. This was done using a large Crescent wrench.

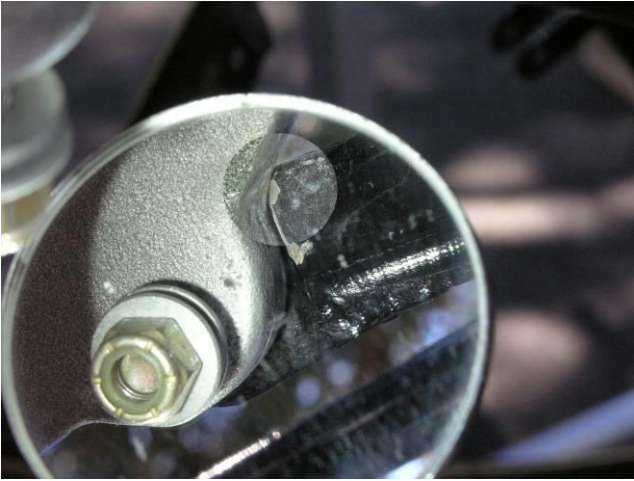
Using the inspection mirror interference between the weld bead and the transmission case can be seen in this picture of the right hand mount underside (the highlighted circle).

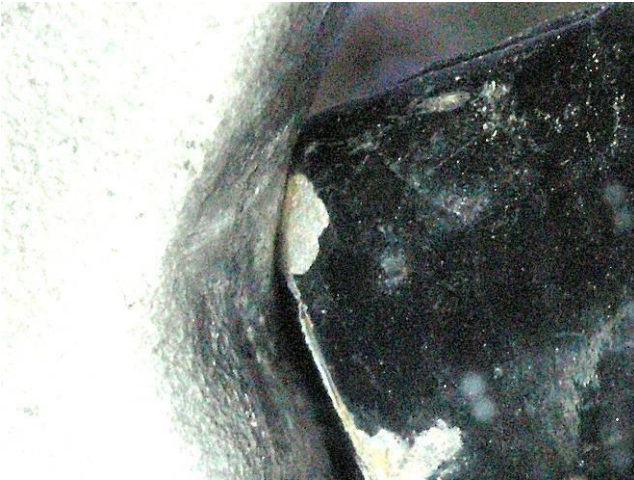
This enlargement shows the interference clearly. Using an air grinder and a flat file I was able to easily remove this portion of the weld bead and clean up the surface for a proper mount. Once the transmission was mounted in place using the left hand mounting bracket, it was offset as detailed in the construction video to account for torque loads in flight. The process is to stretch a string from the transmission drive shaft center directly down the center line of the tail and secure it in the middle of the tail rotor gear box mounting plate.

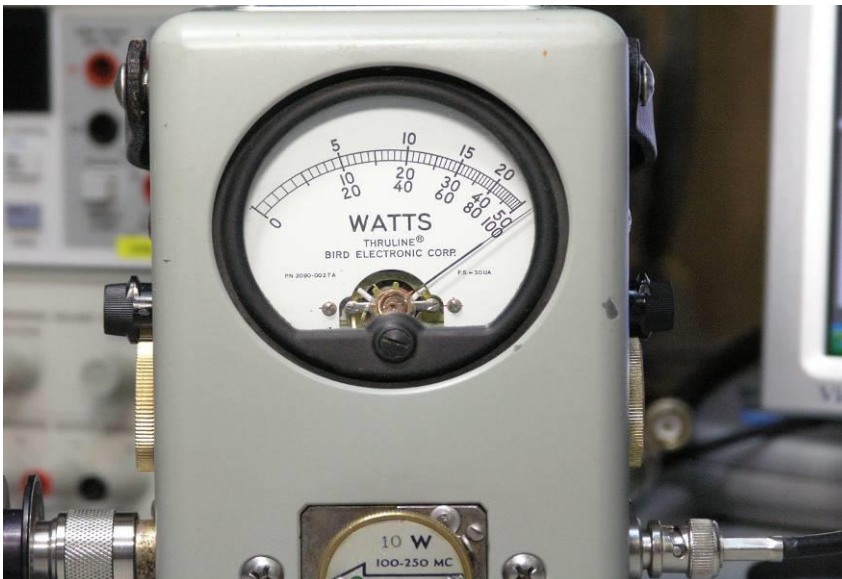
The transceiver is rated at an output of 8 watts but on the bench it's pegging the wattmeter with a 10 watt element installed (bottom scale.)

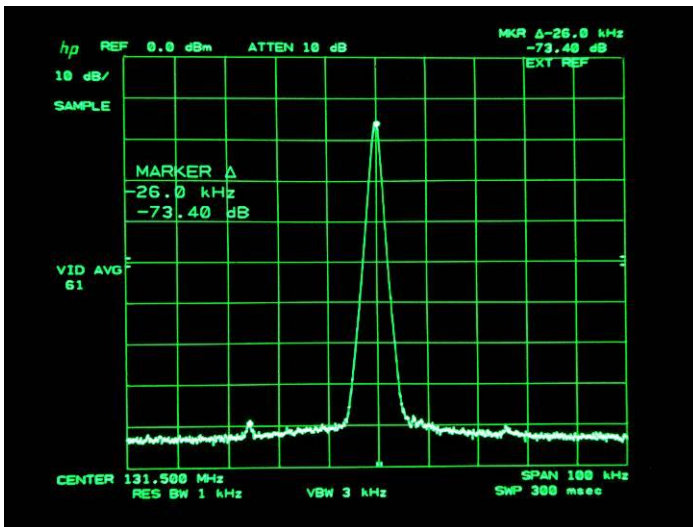
There's a small spur at 26 kHz, probably switching power supply ripple. It's down 73.4 dBc.

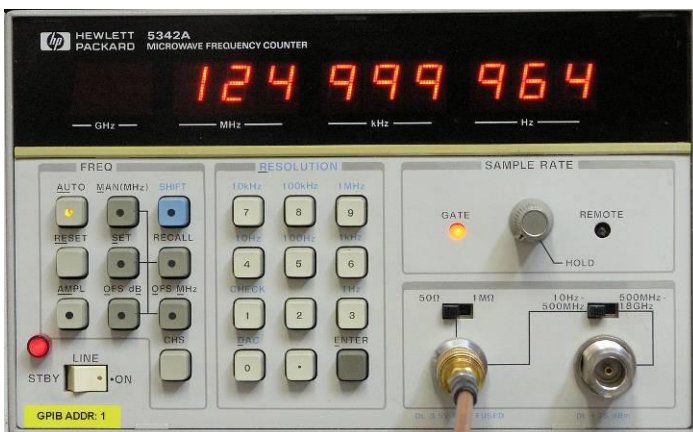
The IC-A210 is off 36 Hz at 125.000 MHz in this bench test. The spec is ± 5 ppm, or 625 Hz.

Bottom line – the radio is performing as expected and exceeding the transmitter specifications for output power and spurious emissions.

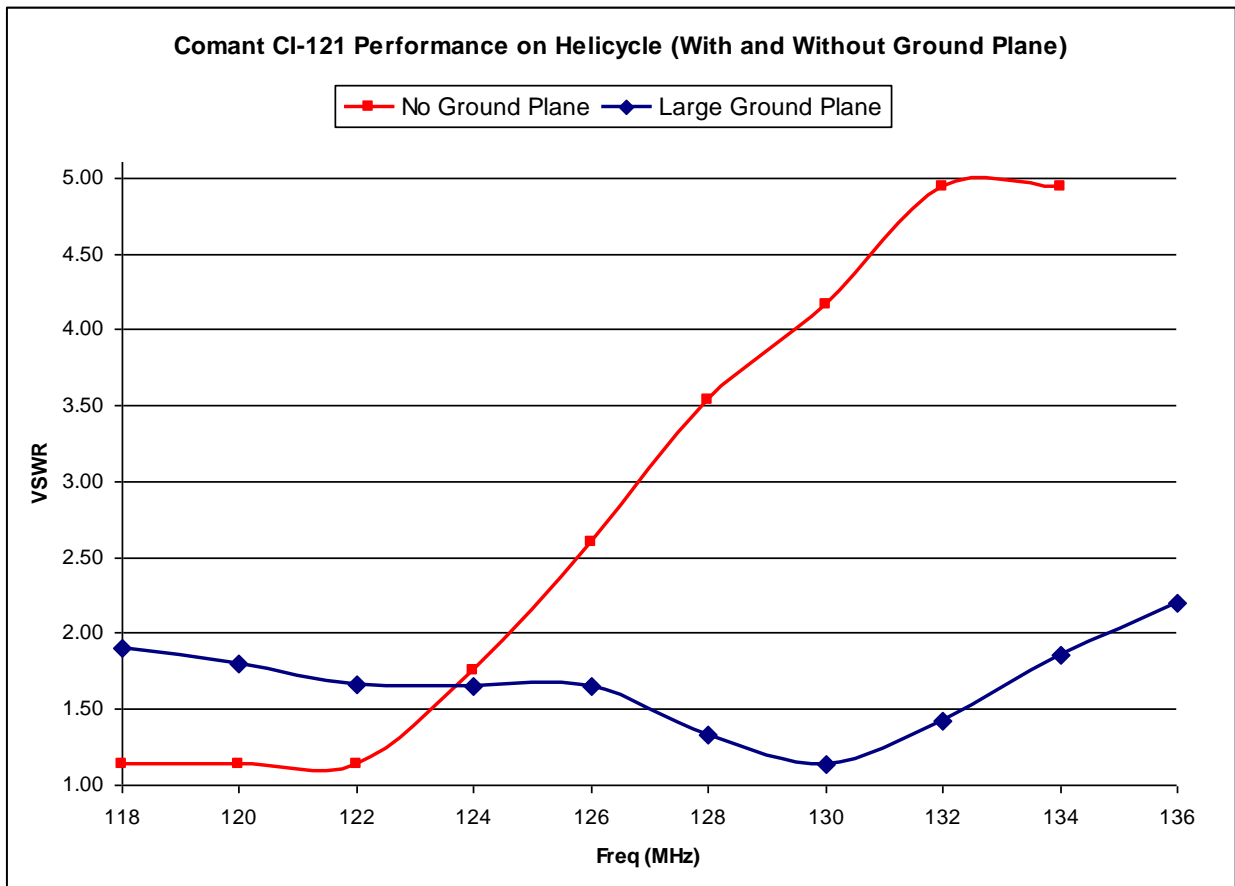
It's painfully obvious that the common Helicycle configuration (the red series) used by most builders (no ground plane other than the frame itself) is not producing a functional antenna installation. This could explain why so many builders have had major problems with EMI getting into the engine control as well as their instruments. This will not be an easy fix.

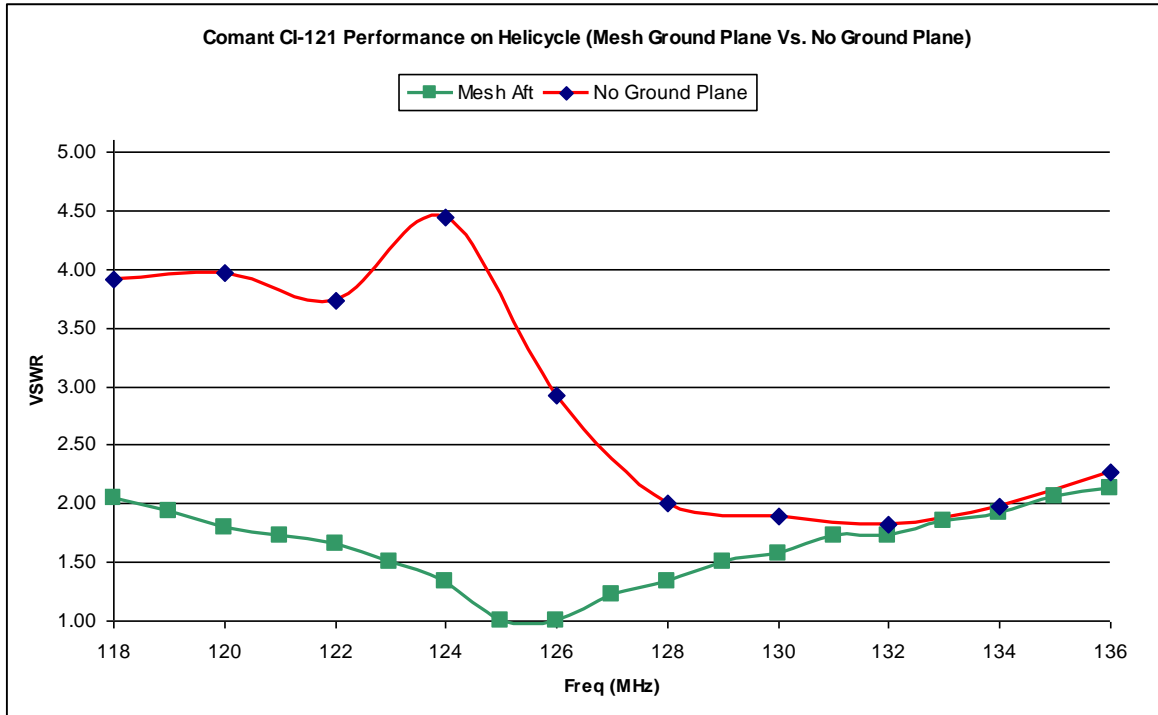
The red data is the antenna without any ground plane – just mounted on the plate. The green data is the antenna mounted under the mesh. Remember, the manufacturer's specification called out a maximum VSWR of 2.5:1 across the aviation band. Here the actual maximum is 2.13:1 right at the band edge.

Another indication that the antenna is functioning properly is that it has its best performance right in the middle of the band and tapers off gracefully on either side. This antenna is a resonant device and it's clearly tuned to the middle of the aviation band.

I don't think bonding the ground plane to the frame will have any affect one way or the other. I am concerned with galvanic corrosion where the aluminum antenna base meets the steel frame. It's critical that the antenna base be in intimate contact with the ground plane.

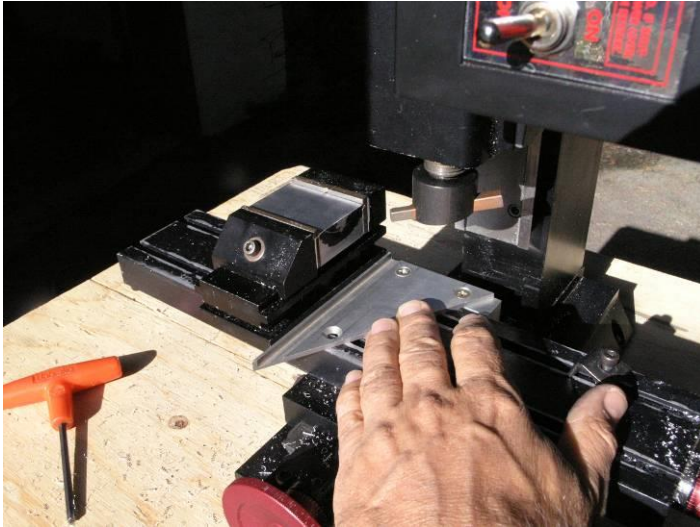
I'm replacing all of the tail rotor drive shaft tubes along with the coupling spiders and the tail rotor coupling to the drive shaft due to very poor workmanship by previous owners.

Two 3/16" AN bolts attach the bearings and couplings at each end of the three drive shaft tubes. The location and placement of these bolts is critical. To help with alignment I made a drill jig using my Sherline mill.

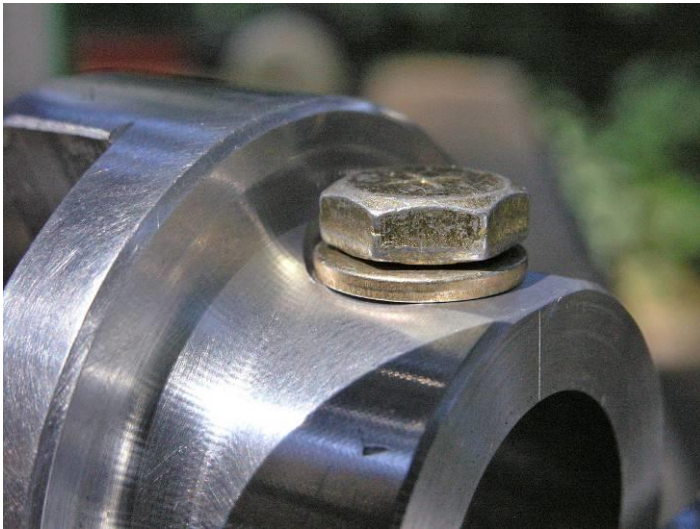
This morning I spent two hours carefully match-drilling this tail rotor coupling's 1/4" bolt holes. They had to match the existing gearbox shaft and not have any slop. Slop in the old coupling was caused by ovaling out the hole by a previous builder. The final sizing was done using a reamer and it came out perfectly.

I noticed that the flat washers do not have a flat purchase on either side. This is true for the transmission coupling as well.

I milled flats into both sides of the coupling as seen here. They do not extend across the entire width of the washer because I did not want to remove any more material than necessary. I will repeat this process for the transmission coupling next.

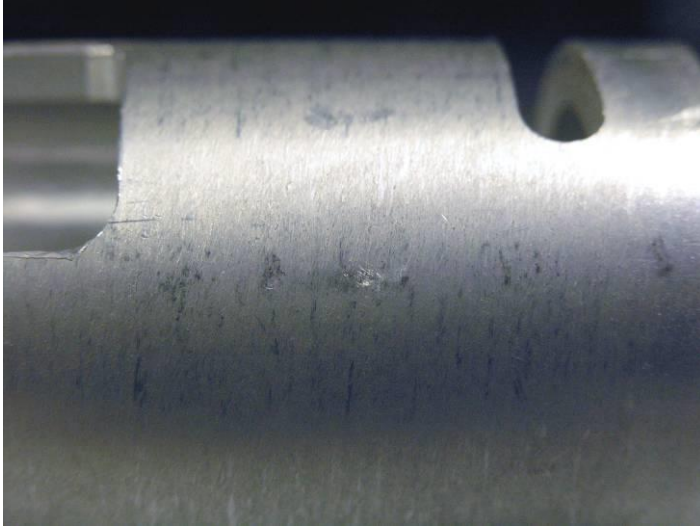
I spent several hours today cleaning up machined parts. This is an example of one fresh out of the bag.

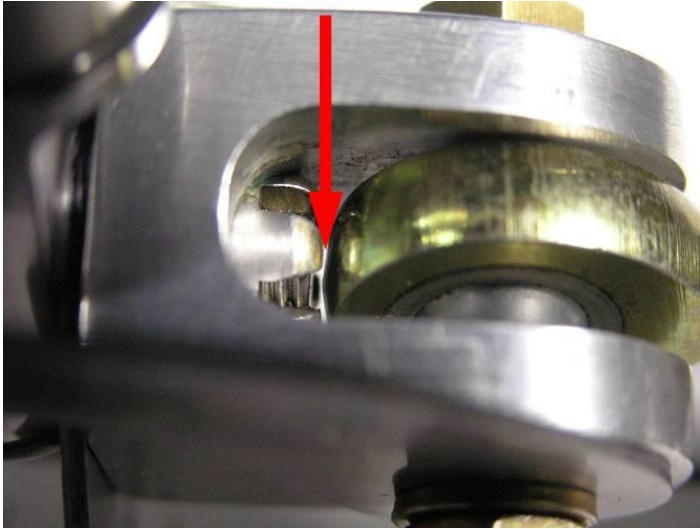
Here you can see the very tight clearance between the rod end and the top of the shortened castle nut (red arrow.) The last step will be to drill the cotter pin hole in the end of the bolt.

NOTE: Accepted practice is to always have a minimum of two threads protruding from the end of a nut but in this case there simply is no room. It's a trade off between the amount of material I take off of the nut and the depth of the counterbore.

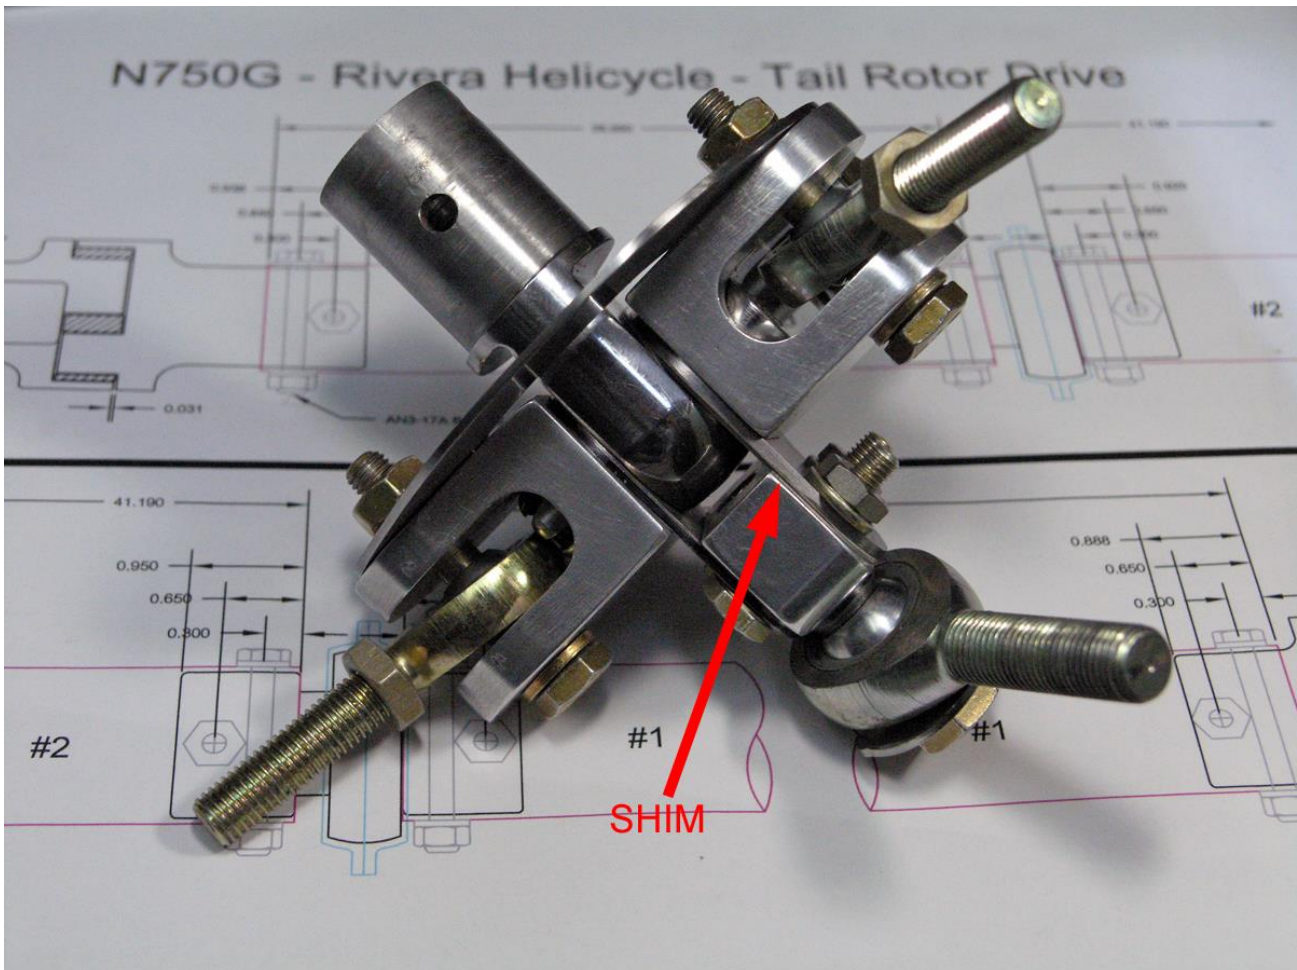
After finishing the work shown above and assembling the mixing assembly I found that the piece shown on the previous page seemed to slightly bind at one end of its travel, as it was rotated. I discovered that the pieces that fit inside of the assembly (the piece in the previous page plus one other) were 0.31" thinner than the inside dimension of the steel welded piece that forms the heart of the assembly.

To get around this 0.031" discrepancy I fabricated a 0.031" thick stainless steel shim. It doesn't look like much but it required a trip across town to the metal supplier and considerable effort to complete.

Here's the almost completed mixer assembly. You can just see the 0.031" shim. All that remains is to Alodine the aluminum parts, drill the cotter pin hole in the bolt and install the pin and replace all the regular nuts with locking hardware.

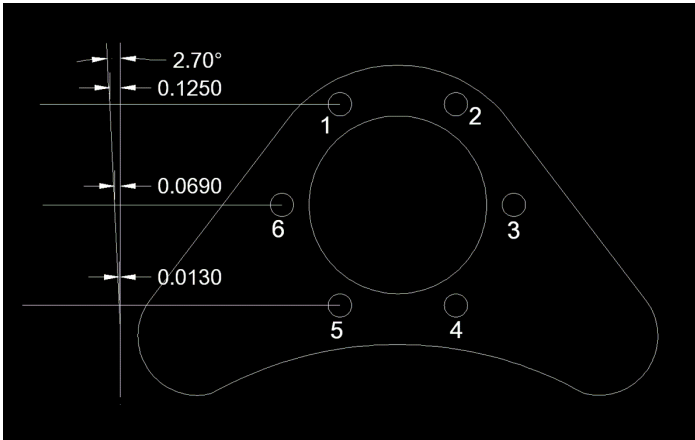
I measured the wedge-shaped gap behind each bolt using automotive feeler gauges. It's very subjective since I'm measuring a wedge with a flat gauge, but I tried to get a snug fit with the gauge centered under each bolt hole. When I run the numbers for the right side of the transmission (left side of the drawing since this is a rear view) they match well and show that the plate is tilted 2.7 degrees from true. Adding shims to align the gearbox impacts the length of the rear drive tube. I failed to take this into account so my rear tube is slightly short by about a tenth of an inch. I'll deal with that tomorrow.

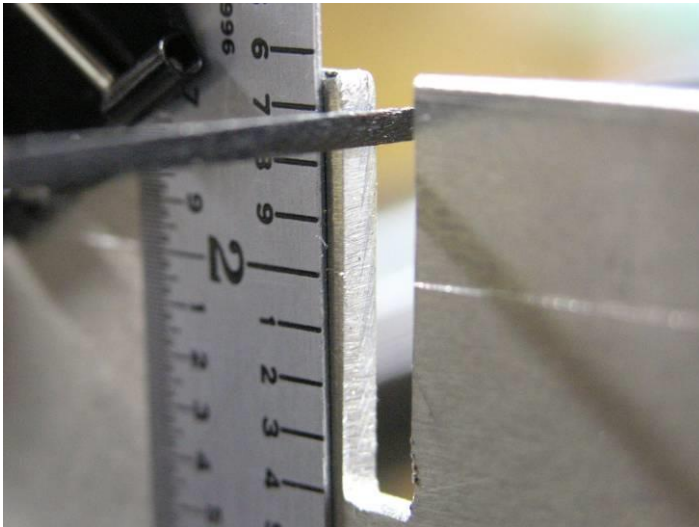
The jig is held in position with the bearing mounting hardware and has a slot in the center to accept the lacing cord. The scribe lines run from the center of one mounting bolt hole to the other and the string should line up with the lines. The steel rule is set with the two inch line on the scribe line.

As seen here, the rear bearing would be almost 0.30" too low. This is a huge error.

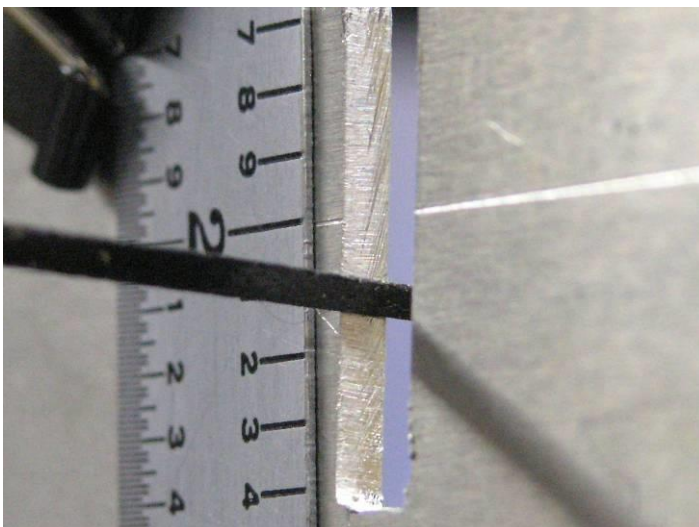
The forward bearing would be about 0.15" too high. I'll watch the construction video again to see what BJ had to say before I start grinding the bracket mounting holes...

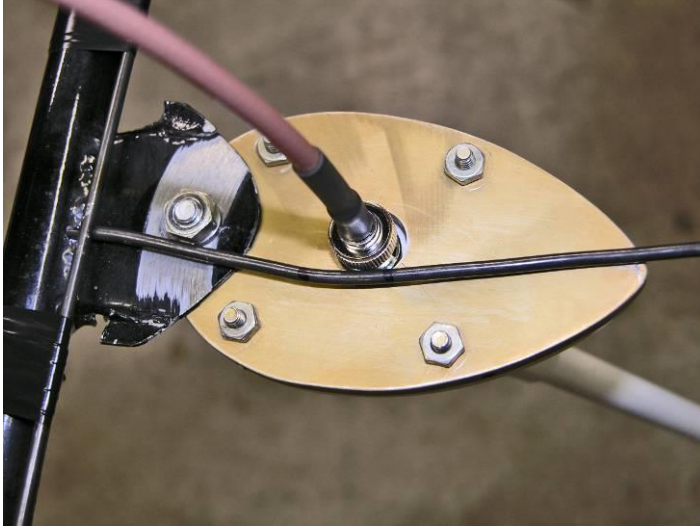
Here's a detail showing that the ground plane currently is not very well bonded to the antenna mount at all. It also isn't bonded to the frame. I currently have it held in position with electrical tape.

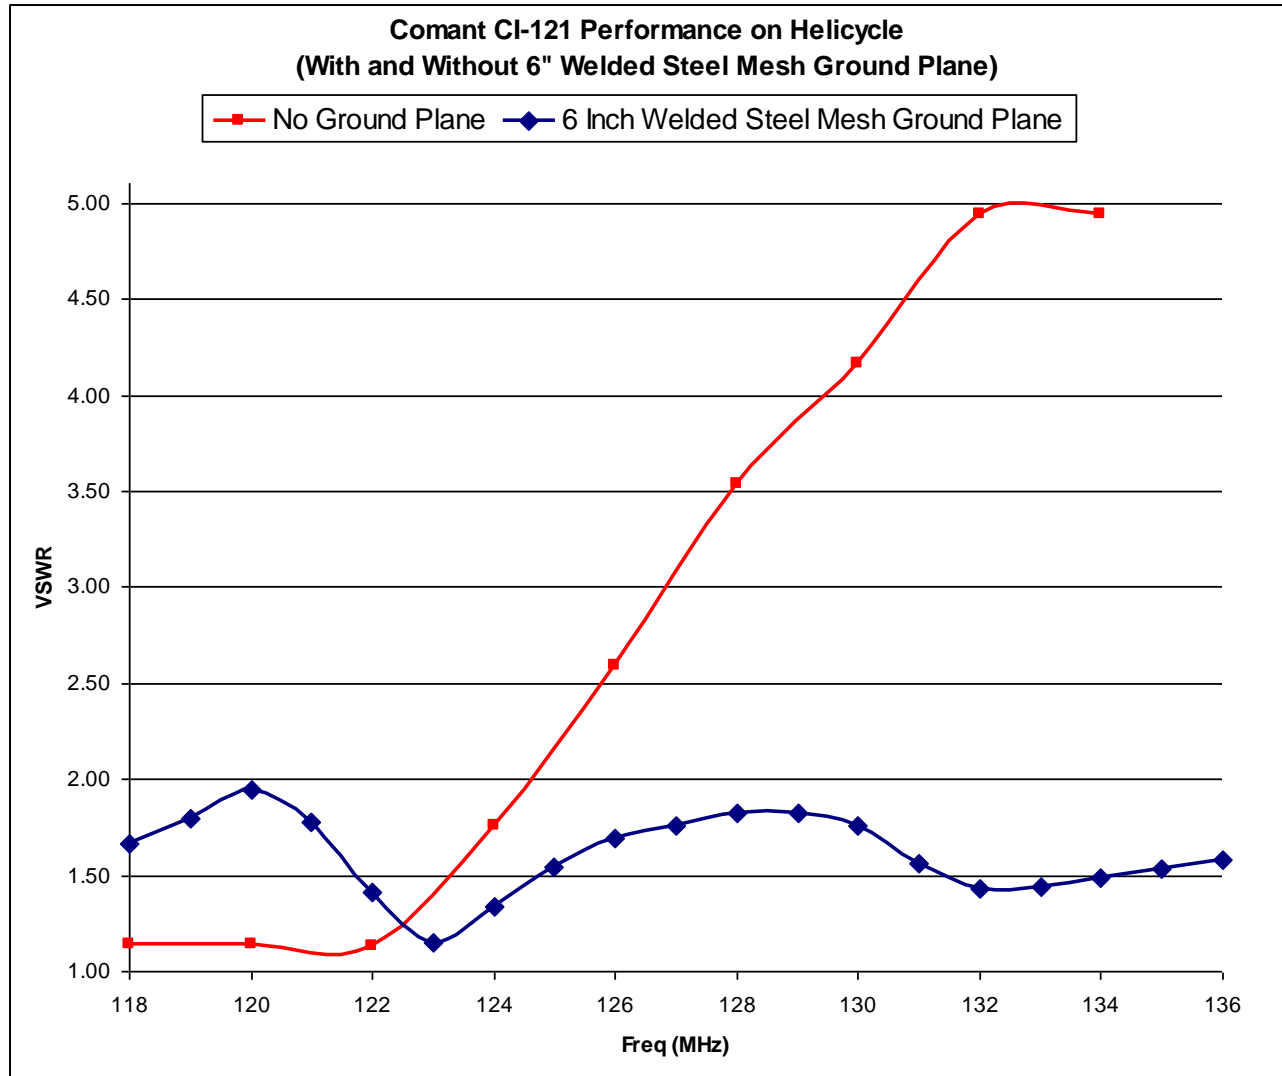
The results speak for themselves. The antenna manufacturer specifies a maximum VSWR of 2.50 across the aviation band. As shown by the blue plot, the maximum VSWR is less than 2.0 and that's very good. You can also see what sort of results is obtained by simply mounting the antenna on the mounting bracket with no ground plane. I believe the lack of a ground plane is responsible for many of the EMI problems that Helicycle owners have and are experiencing.

With this 6-inch mesh the ground plane will be unobtrusive and not introduce any noticeable drag. It should go a long way towards providing me with a reliable electrical system with a minimum of EMI problems. Time will tell...

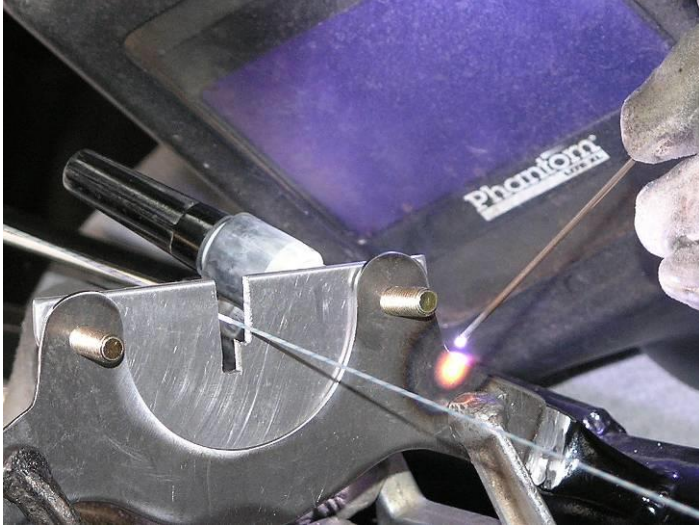
For the past few weeks I've been out of town on a business trip. Before I left I took my frame up to Hap Miller's shop. Since my kit is a build-1 all of the engine brackets and many others are not correct for the turbine engine. Hap and Zack helped me resolve all of the missing and incorrect bracketry. Here Zack is welding the rear bearing mount bracket in the correct position based on my earlier diagnosis. We first had to fabricate a new bracket out of .050" chromoly sheet.

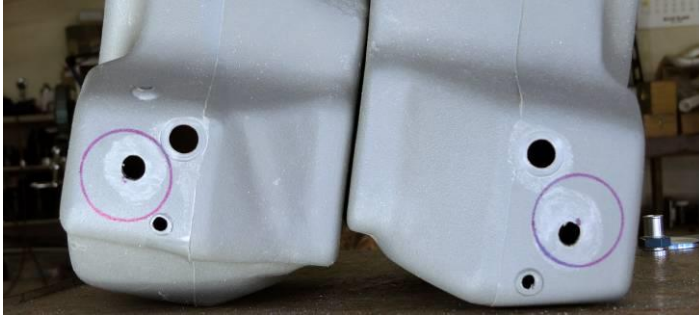
It's time to move on to the fuel system. The first step is to greatly enlarge the holes that are circled on the two bottom tanks. They allow access into the tanks, and the optional Westberg fuel probe is mounted in the left tank. Care must be taken to leave enough room for the nuts that secure the fittings for the fill and vent lines. Notice how different the two tanks are...

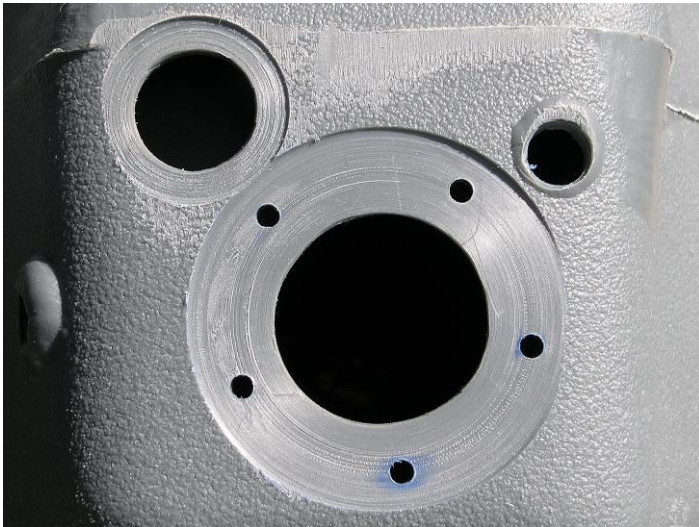
Here's a detail picture of the left tank, with the rough surface area around the holes recessed and smoothed. This is especially important on the large opening so that the o-ring will seat properly and seal the tank. Since the surface of the tank falls away towards the edges, the large hole must be as close to the two smaller holes as possible but still leave enough room for mounting hardware. This tank takes the Westberg fuel probe so the 5 mounting holes are not quite equally spaced. They needed to be aligned carefully to orient the fuel probe and its wiring.

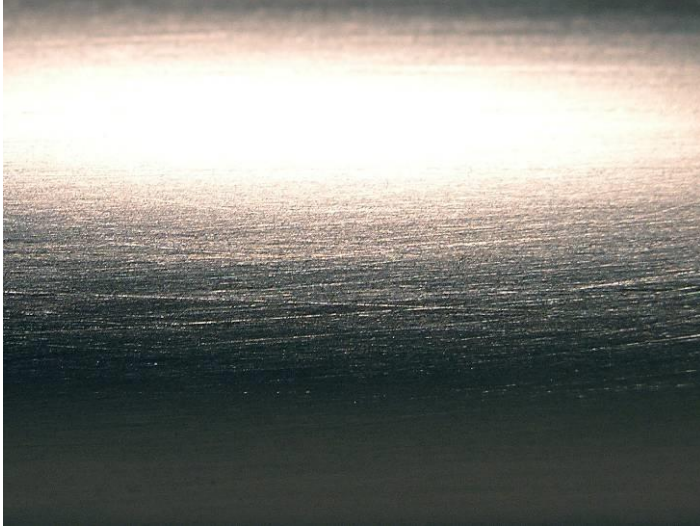
Here's that same pitch link after sanding with 600 grit wet and dry paper. Most of the large scratches are now removed.

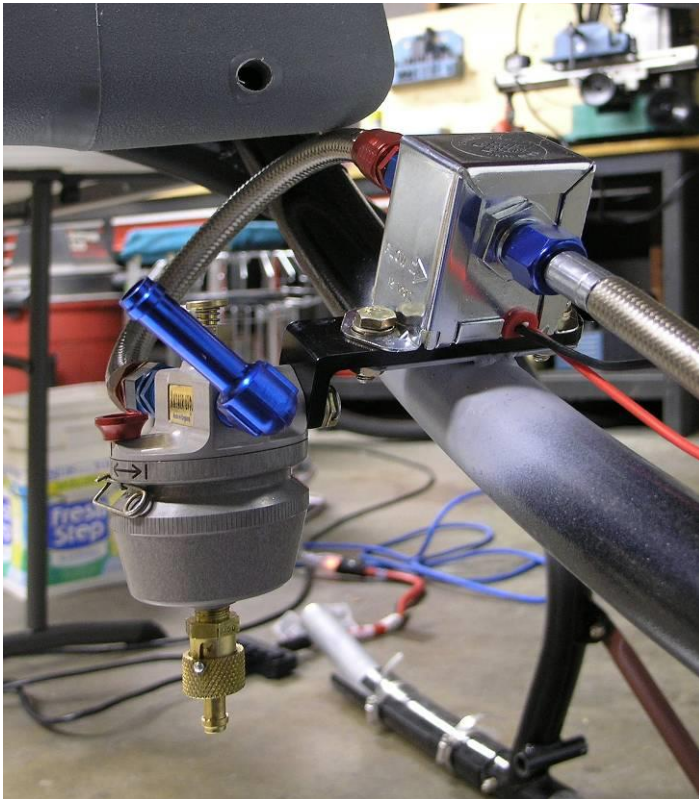
This picture is looking towards the rear and shot from where the seat will be. I still have to decide what to do with the lower tank drains. The hole in the tank is the lower left drain. It's so close to the bend in the tank that I might not be able to use the tank upgrade fittings. Hap suggests using epoxy and an AN plug to seal these holes and then mount the larger upgraded fittings underneath the tanks. So far that looks promising.

The brass nuts holding the fuel pump will be replaced with locking nuts when the assembly is installed permanently. The FAA says fiber or nylon locking nuts should not be reused if the nut cannot meet the minimum torque requirements since they wear out. It's safer to just throw lock nuts out if they've been used even once and use new ones. I try not to use my lock nuts at all at this stage in the project.

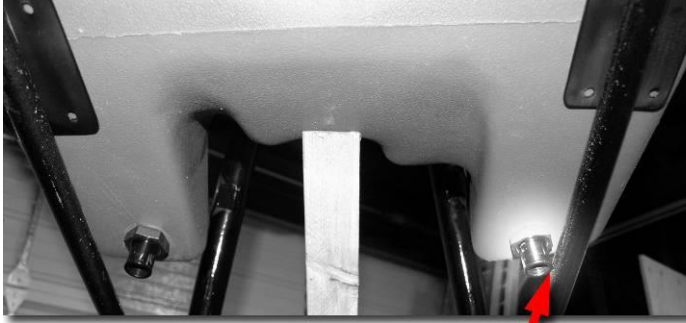
Well, I finally finished all the plumbing holes in the top tank, match-drilled the mounting holes, installed the drain fittings, and washed out all the debris.

I wedged it into position (using the 2x2 in the middle of the picture) to check alignment of the mounting holes and discovered that the right hand drain fitting is almost touching the frame.

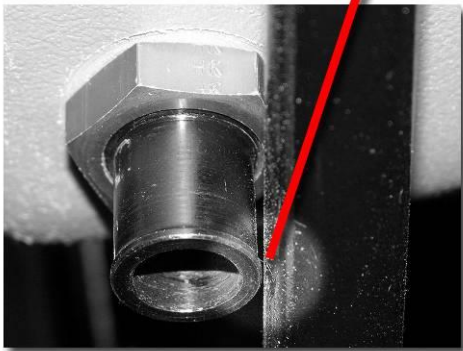
There isn't enough room to install the drain hose and hose clamp without them rubbing against the frame tube. I can't oval out the hole and slide the fitting over because the hole needs to be perfectly rounded and exactly the correct size so the drain fitting's o-ring will seal properly. If I try to bend that tube slightly I'll be introducing all sorts of stress into the frame and probably twist it out of alignment. This is not good. I may have to scrap that tank and they're expensive.

I checked with another builder and his right hand fitting is almost as close as mine. Every frame is slightly different and maybe the tanks are too. I've tried to be as careful as I can but things like this occasionally catch me by surprise. These holes were already drilled so there wouldn't have been much I could do except to cock the tank sideways in the frame slightly and that isn't a good idea either.

I have an idea – I can replace this fitting with an adapter to a 37° flared fitting and then use Aeroquip fuel lines instead of the much larger rubber hose provided. It's much more expensive and the flow out of the top tank will be considerably less. This could be a very serious concern since you could be fooled into thinking that all your tanks had been filled when in fact only the top tank was full and fuel was still running down the smaller lines to the two bottom tanks and the aux tank. I believe this happened to someone and it resulted in an in-flight flame-out and forced autorotation when he ran out of fuel. I'll have to give this a lot of thought before I decide what to do.

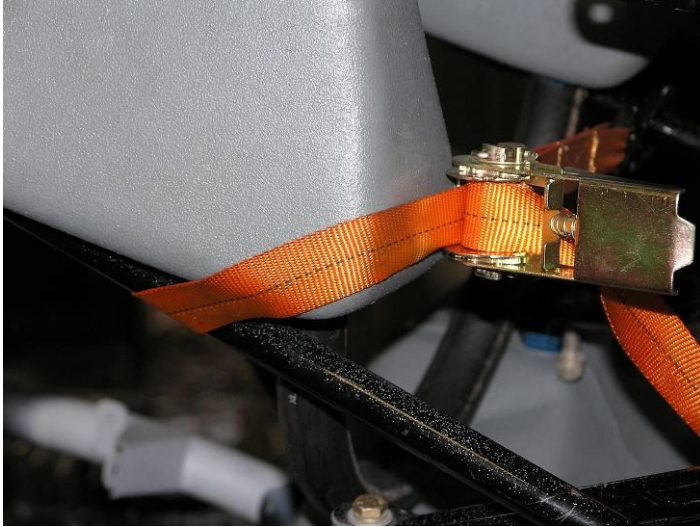
I let it sit for a few minutes and then I pulled the right hand lower portion towards the middle of the frame using a nylon cargo strap as you see here. With the strap pulled tight I had a pretty good clearance on the right hand drain. I let it sit for a while and then drained the hot water out and quickly ran lots of cold water through the tank to cool it in its new form.

First I boiled up a big pot of water in the kitchen. Then, after sealing the bottom drains, and mounting the tank using the four o-ring screws, I poured the hot water into the tank.

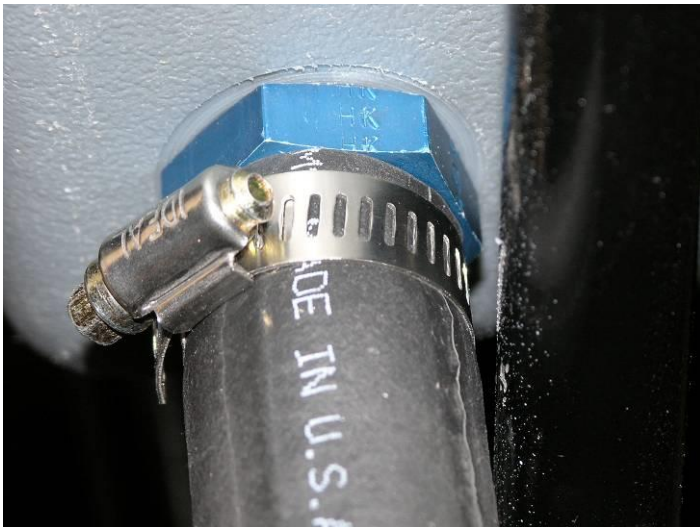
Here's the result. That worked out fairly painlessly and now I have enough room to get that hose in there along with its clamp and not rub against the frame.

I think the tank may tend to return to its previous shape but it looks ok at the moment...

Note – Within six months it returned to its original position.

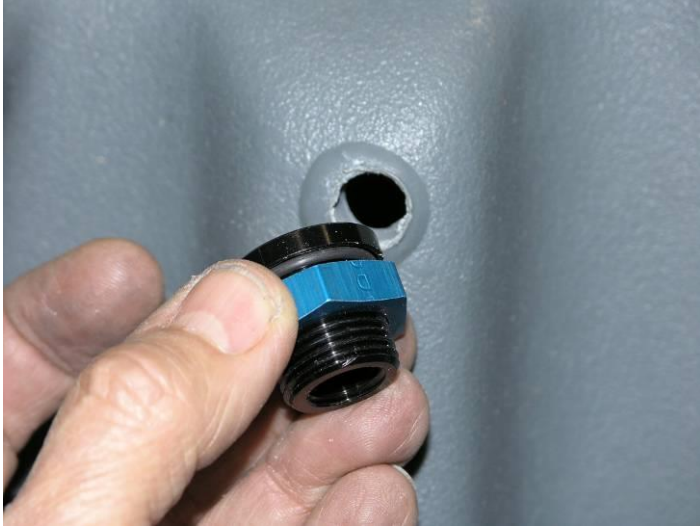
In the earlier kits the fittings were screwed directly into the polyethylene tanks. That bump with the hole is where a typical fitting would mount. Things have changed for the better and now a threaded adapter with an o-ring seal is installed in the tank and the fuel fitting screws into it. All of the new parts are available as a tank upgrade kit which I purchased. The fittings were bare aluminum and the nuts were blue anodized. I sent all of my bare aluminum parts out and had them black anodized as you see here.

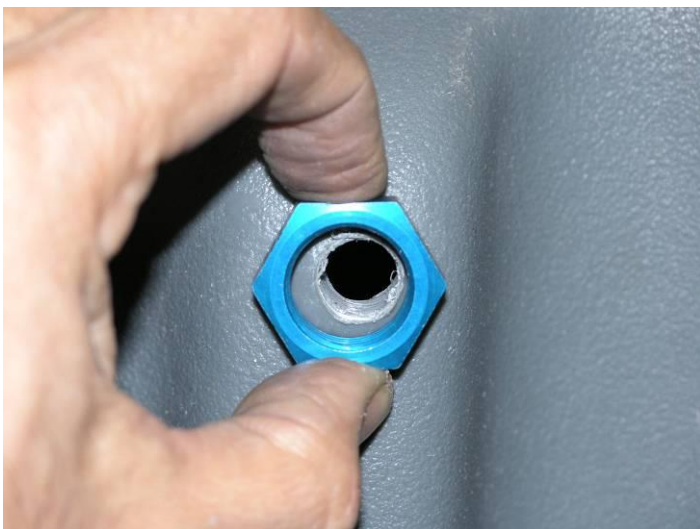
Then the enlarged hole might need to be offset so that there will be enough of a flat area on the inside of the tank to allow the o-ring to seal properly. You can see that this fitting is going to mount on a raised area of the tank that is barely larger than the fitting itself.

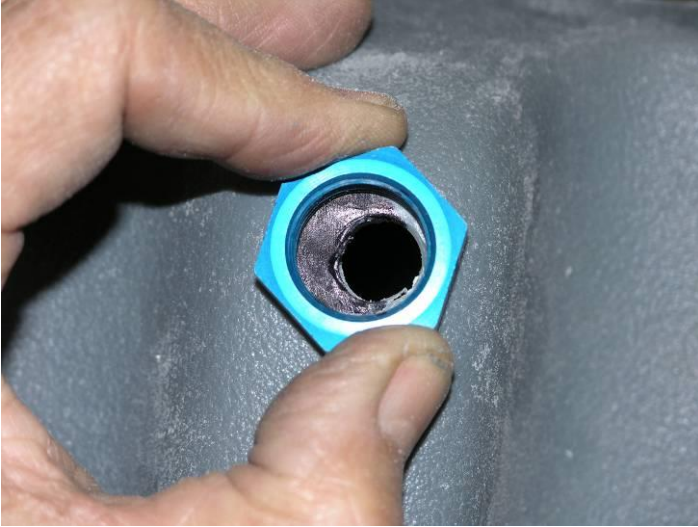
It's important not to get carried away and make the hole too large because the o-ring mounts right at the edge of the hole.

I've marked out the offset location of the enlarged hole in preparation for grinding. I used several different sized burrs to enlarge the hole and then finished up with a large rat-tailed round file and a deburring tool.
